SWOT FIELD IMPLEMENTATION REPORT

Nyarugusu Refugee Camp, Kigoma Province, Tanzania
UNHCR | NRC

JUNE 2021

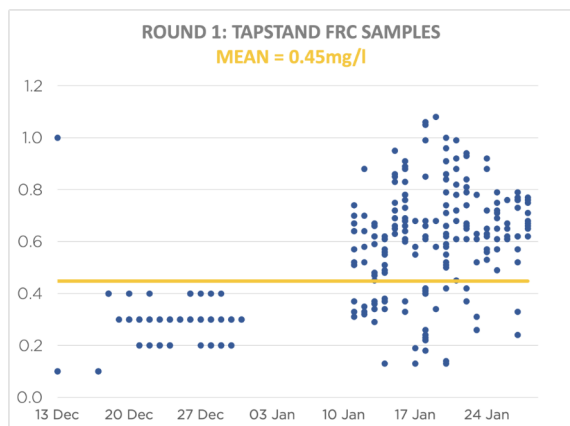
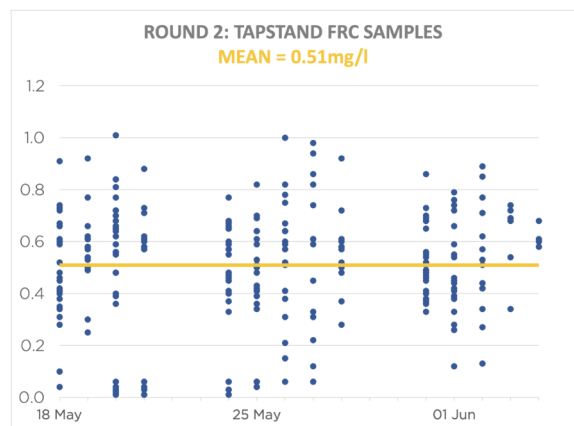
Figure 1: FRC measured at tapstands during round 1 and round 2

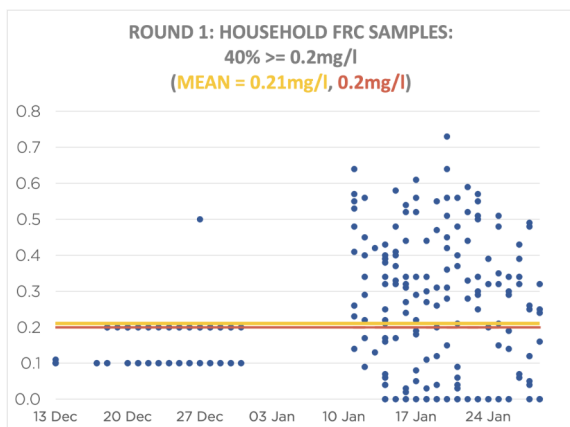
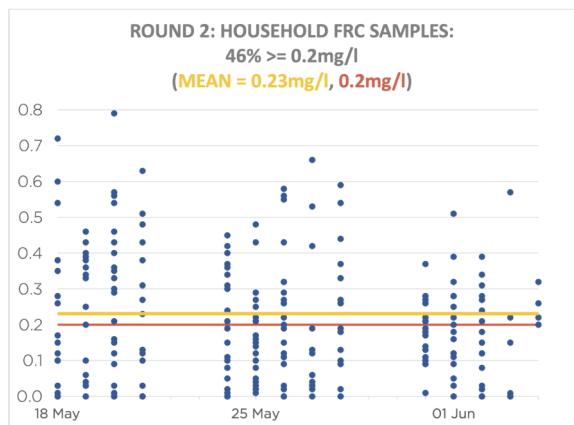
Figure 2: FRC measured at households during round 1 and round 2, showing protective FRC (0.2mg/l)

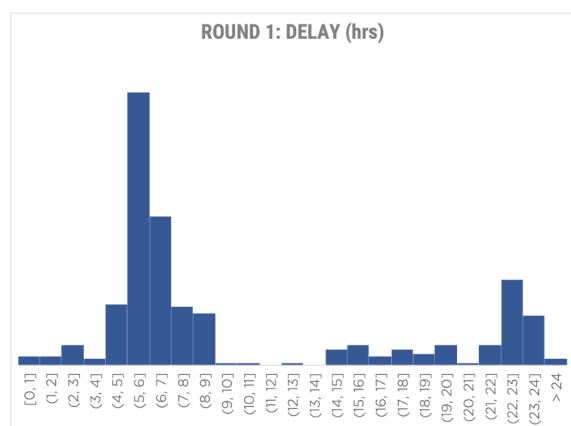
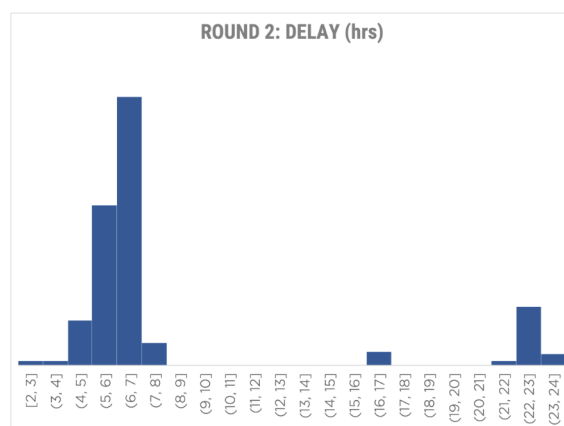
Figure 4: Delay between tapstand and household samples

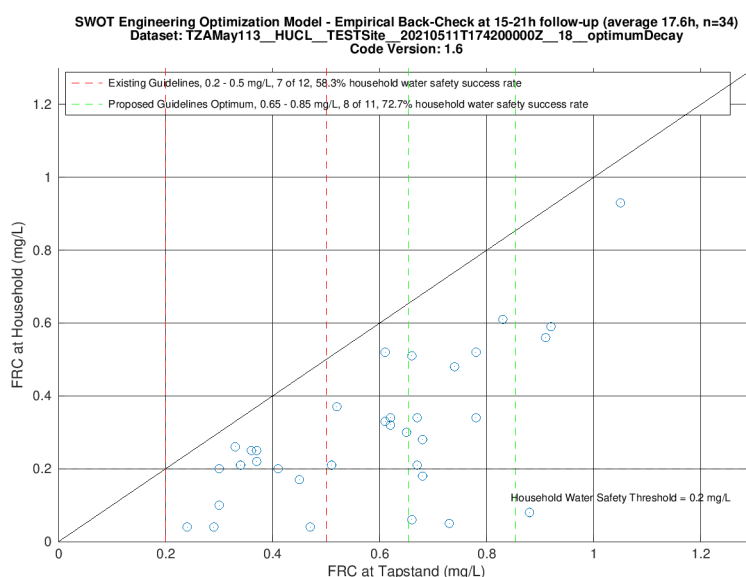
Figure 5: Empirical back-check of the round 1 SWOT results

Round 1: For an 18-hour duration of protection, the SWOT generated a tapstand FRC recommendation of 0.75 mg/L.

Figure 5 depicts a retrospective empirical analysis of how the SWOT recommendation compares to the status quo Sphere FRC target (i.e., 0.2 - 0.5 mg/L) with respect to ensuring household water safety (i.e., FRC > 0.2 mg/L) in data where household follow-up occurred between 18 +/- 3 hours post-distribution (n=34, average post-distribution time: 17.6 hours).
